HISTORIC STRUCTURE REPORT

NHL FERRYBOAT EUREKA

National Park Service | September 2022 - 100% Final

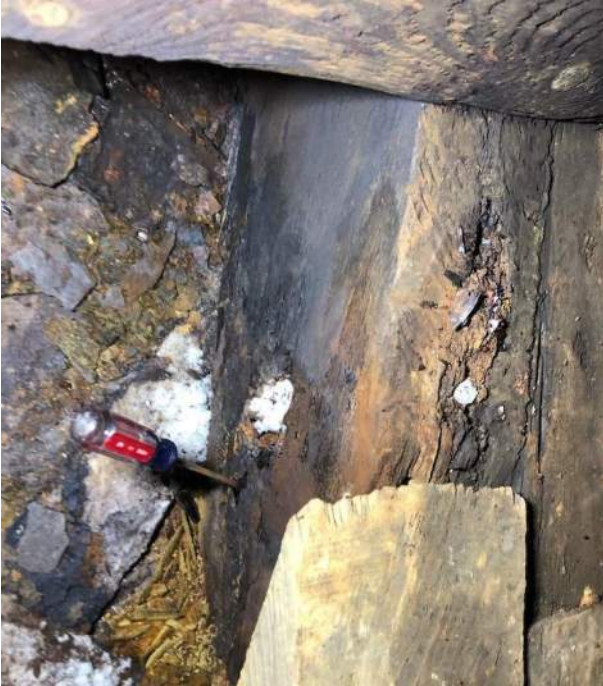
Photo 7: Frame Heel Decay

Below the t'ween deck the bilges were found typical for this vessel. Standing water was noted in the bilges and while the level is well under the top of the floor timbers, there are also indications in this space that the water level has been or is periodically above the floor timbers. White crystals were observed on almost all of the visible fasteners including the futtocks, keel, side keelsons, bilge stringers and ceiling.

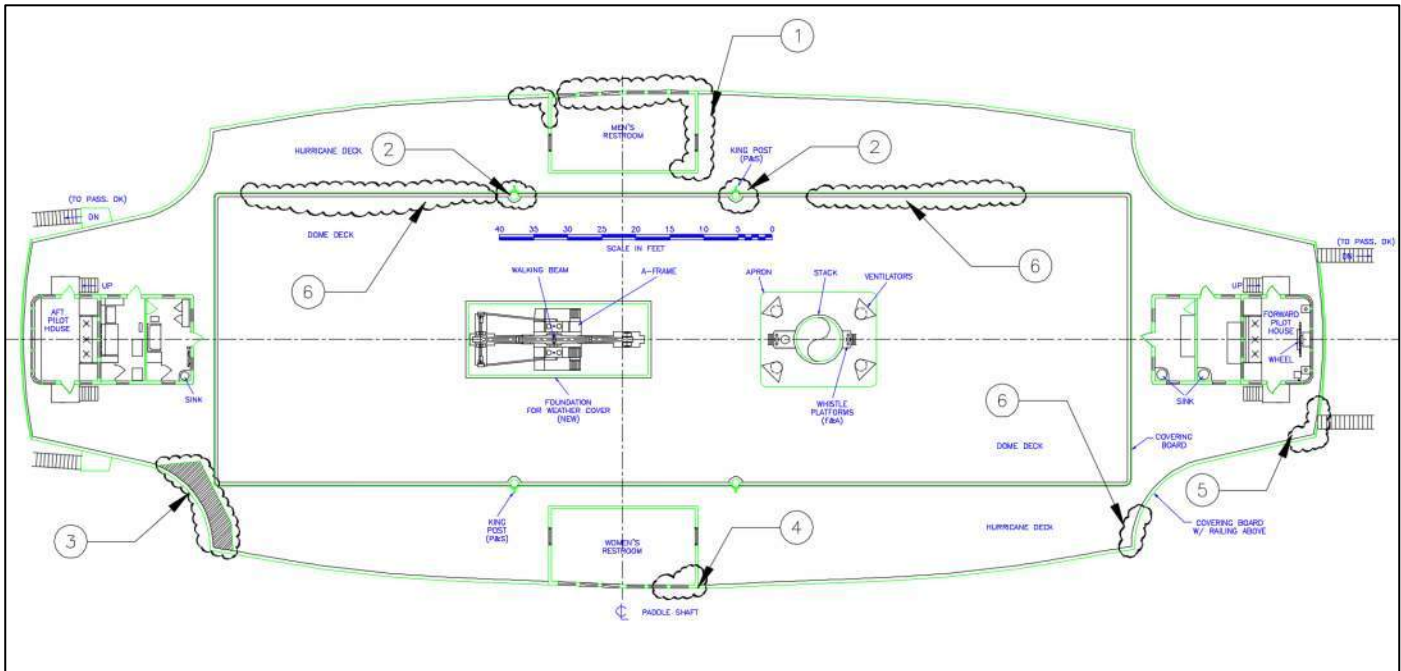
Figure 11: Rot Locations on Hurricane Deck

Standing water was observed in several areas on the hurricane deck roof surface including in the area forward of the male head on the outboard side of the vessel. Water in this area has permeated the structure and as noted in the 1990 condition report there is extensive advanced decay in this area.

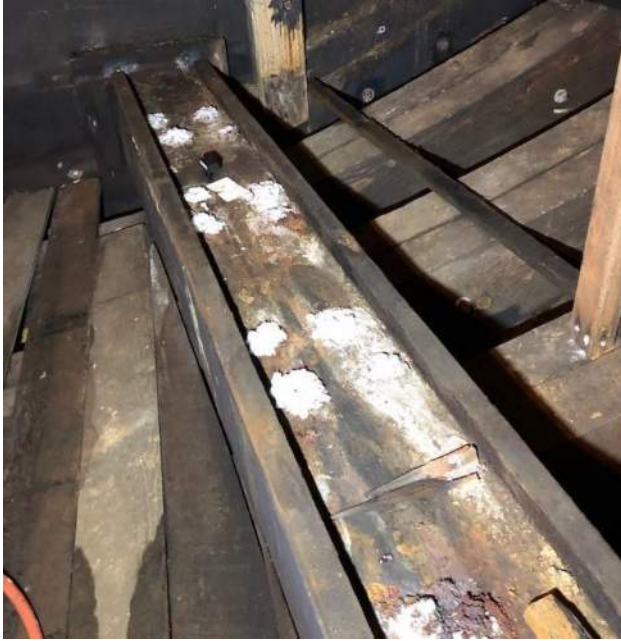
Photo 14: Salt Deposits on Bilge Fasteners

In March 2018, the United States Department of Agriculture performed an assessment of fastener corrosion and salt damage in the bilge of the *Eureka*. The discussion on corrosion in that report stated: “when wood moisture content (M.C.) is below 15% to 18%, embedded metals do not corrode. As the moisture content increases above this threshold, the corrosion rate increases rapidly with increasing moisture content before plateauing at a maximum corrosion rate at approximately 30% M.C.” (Zelinka & Kirker, 2018) Their study goes on to discuss other factors that affect corrosion. But what is important here is that the report states that the mean moisture content of the wood in the *Eureka* is 45%, indicating that *Eureka*’s fasteners are continually corroding.

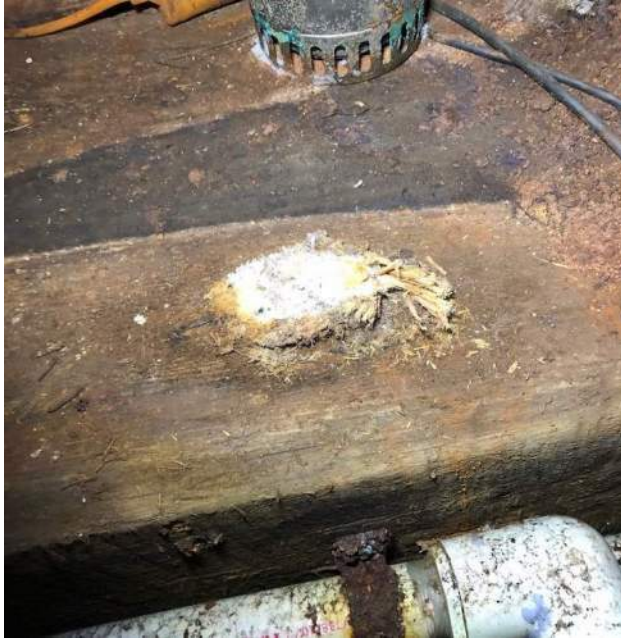
During my examination of the *Eureka*, I noted that the M.C. exceeded 30% for all readings taken of planks, keelsons and side keelsons below the waterline. Moisture content of the internal ceiling depended on whether water was leaking onto the timbers from leaks in the deck. Where there were leaks, the M.C. exceeded 30%, if not, the M.C. was around 20%. This was also true of other wood structure, reinforcing the conclusions found in the Department of Agriculture’s report.

Photo 15: Wood Damage in the Vicinity of White Crystalline Deposits

For the white crystals, there are two separate conditions that, due to the age of the vessel, are easily conflated, but which are closely connected. First, seawater (in this case, the seawater that saturates the wood below the waterline) contains a number of dissolved salts, and while usually they are found in small concentrations, for the *Eureka*, “they can become concentrated in within wood. Particularly near the waterline where evaporative water losses can concentrate salts.” (Jagels, 1992) The *Eureka* presents the perfect environmental conditions for the formation of salt crystals through evaporation. The second and larger concern is that salt crystal formation is also a byproduct of a chemical reaction that occurs in wet wood adjacent to a metal fastener that is corroding.

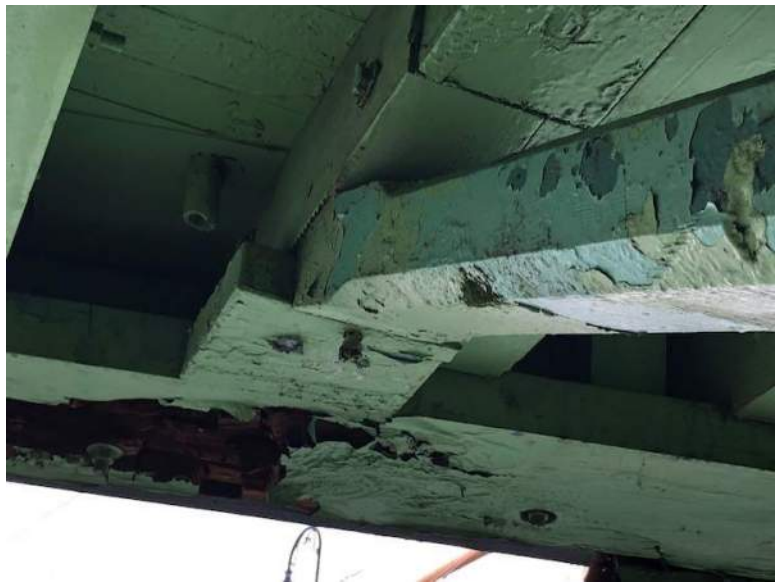
Photo 23: Rub Rail & Apron Rot

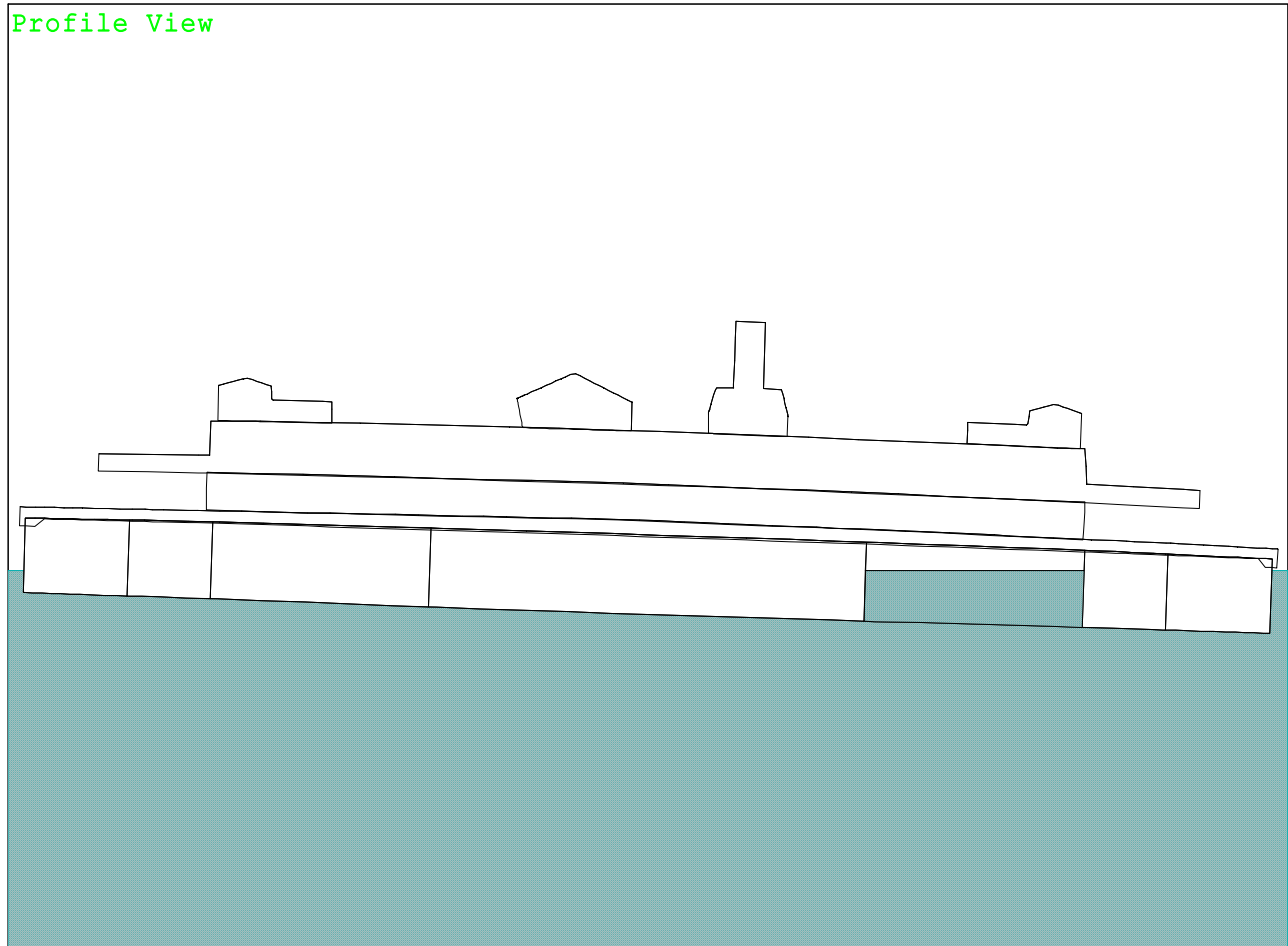
Damage Case 4 -- Engine Room Flooded
FREEBOARD STATUS
Origin Depth: -6.098
Trim: Fwd 0.02 deg., Heel: Port 179.90 deg.
Least freeboard is -10.74 Ft located at 11.71f
Least extra freeboard (to margin line) is -10.74 Ft located at 11.71f

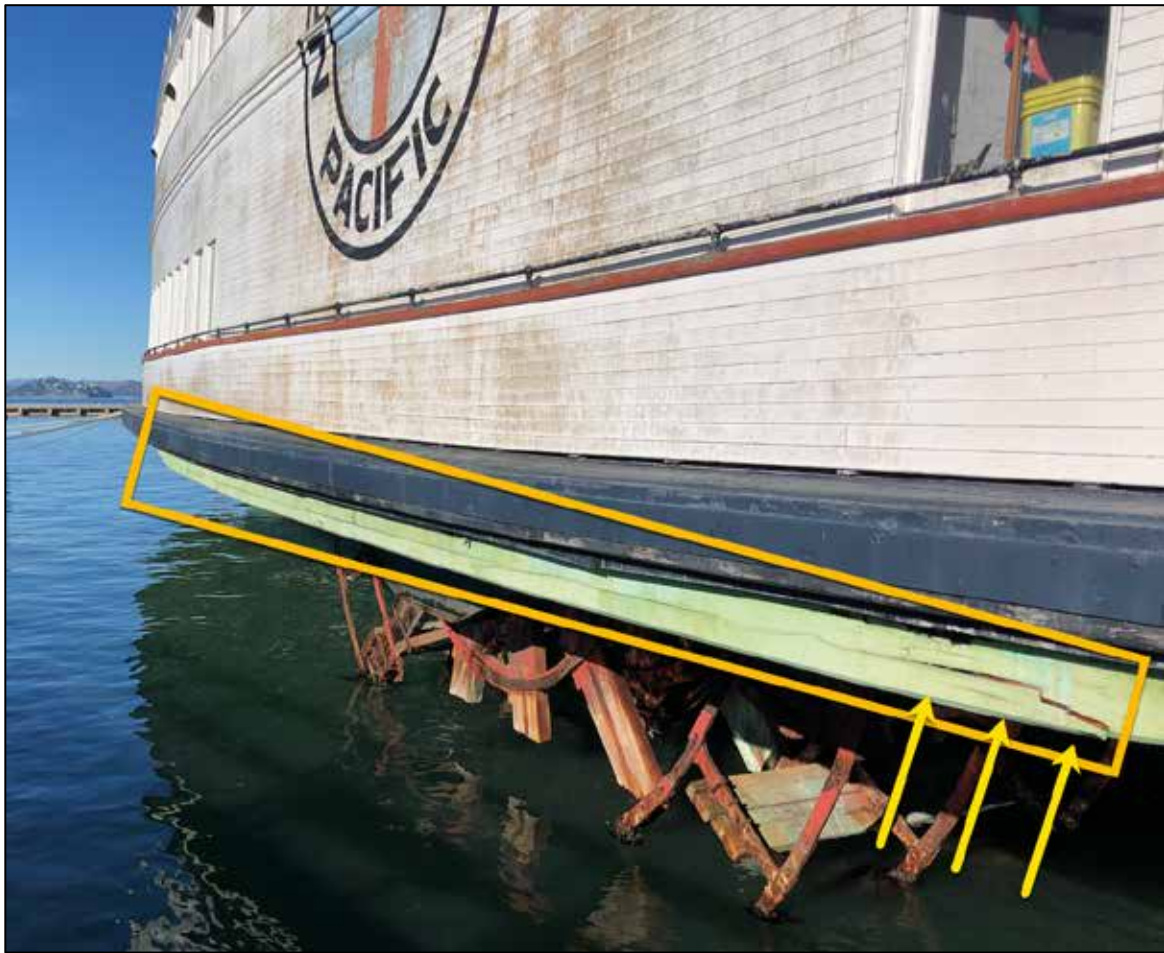
Photo 7

Photo of starboard side support structure for paddle wheel enclosure. Note arrows point to advanced decay. (2020)

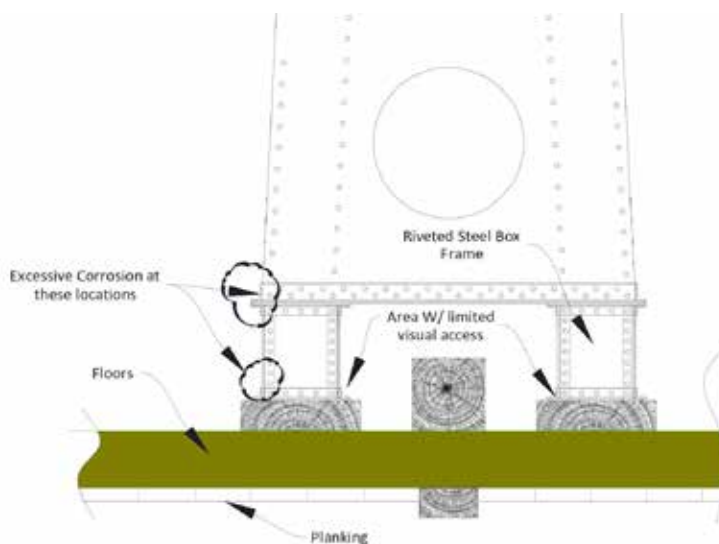
Figure 3

especially where the steel is in direct contact with wet wood. In these areas, the steel may require evaluation and in extreme cases will require repair. The extent of the repair will depend on the amount of plate loss and criticality of the area in question. Importantly, due to the construction of the box girders and its location in the lower bilge much of that structure cannot be easily examined. Based on the condition of the structure that is visible it should be assumed that this condition is prevalent throughout, especially in the lower areas of the bilge and in areas with limited access. (See Figure 3.)

Section views of Steamer Eureka's main engine foundation noting areas with excessive corrosion. View at approximately Frame 8 looking into crankcase.

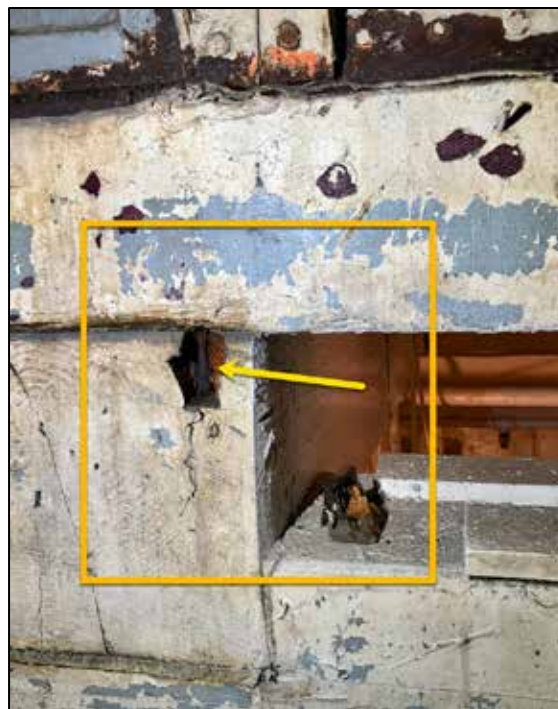
Photo 10

Photo 10, and Photo 11 were taken during the inspection of the fastener in question. Due to the size of the timbers in this location of the vessel, the fastener in question is presumed to be a 7/8" diameter bolt. The bolt seen in the picture is extensively corroded, and the expansion of the resulting rust has damaged the end of the deck beam. The corroded diameter is not evident in the picture, but the diameter has been reduced by more than 80%.

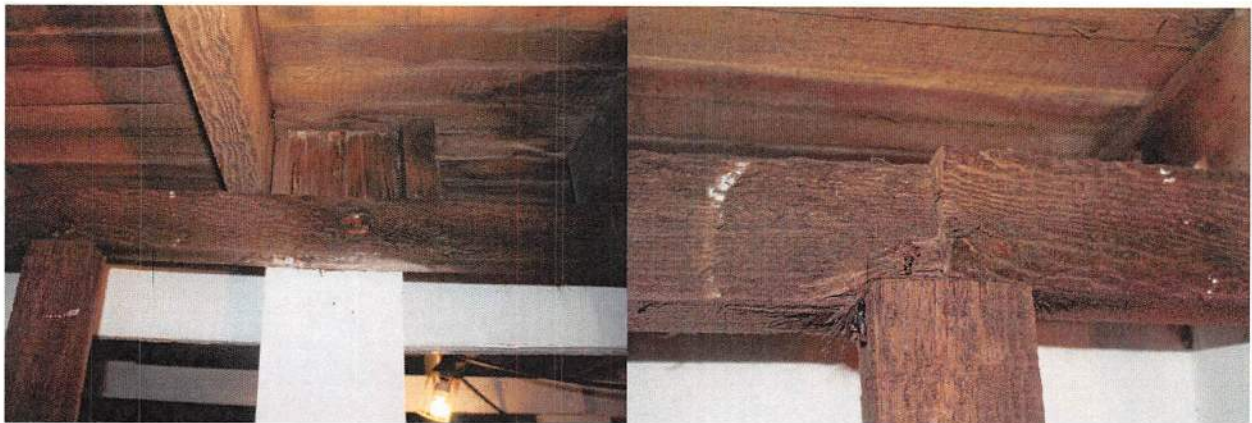
Visually, the bilge in the aft of the ship was in better condition. There was less liquid water in that bilge. Also, there were new wood beams that had been added to support the deck above it. This was important as there were signs of structural failure of some of the old (original) joists (Figure 3).

Figure 3: (Left) new structural members to hold up deck. (Right) Structural failure of old wooden beams caused by salt damage.

Figure 10 shows an SEM micrograph of the wood taken from one of the salt damaged joists (Figure 3). The SEM shows classic signs of salt damage where the tracheids are separated from each other and embrittled. The embrittlement can be detected by fractured tracheids. The “fuzzy” appearance of the salt damaged wood in Figure 10 comes from large agglomerates of these separated tracheids. The salt damage can also be observed by salt crystals, which appear as cubes along the tracheids. As part of the SEM analysis, Energy Dispersive X-ray Spectroscopy (EDS) was performed to identify the elements present. In addition to carbon and oxygen, the wood sample in Figure x contained large amounts of sodium, calcium, and chlorine, further confirming salt damage in the wood.

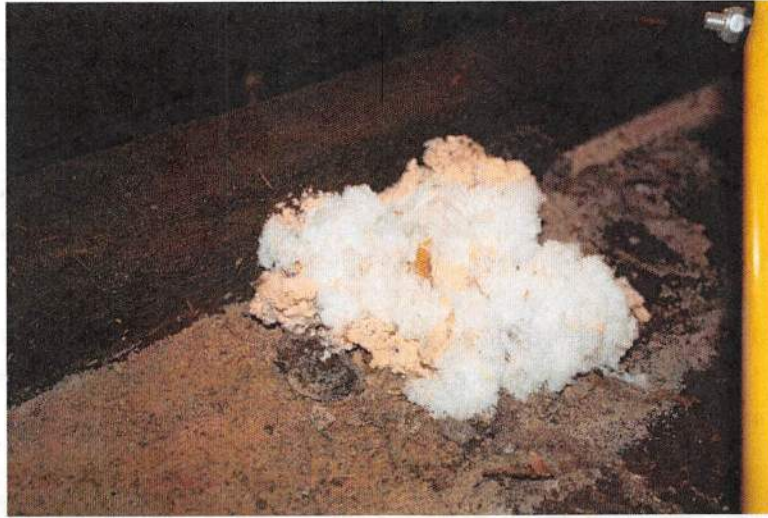
Figure 4: White corrosion product on top of metal fasteners in the forward bilge.

Figure 11 is an SEM micrograph from the white corrosion deposit (Figure 4). The white deposit appeared mostly amorphous but contained some cubic crystals. EDS confirmed that the cubic crystals were indeed crystals of rock salt (NaCl). The amorphous region was predominantly sodium chloride with iron in it as well (presumably from the corroded fastener underneath the surface).

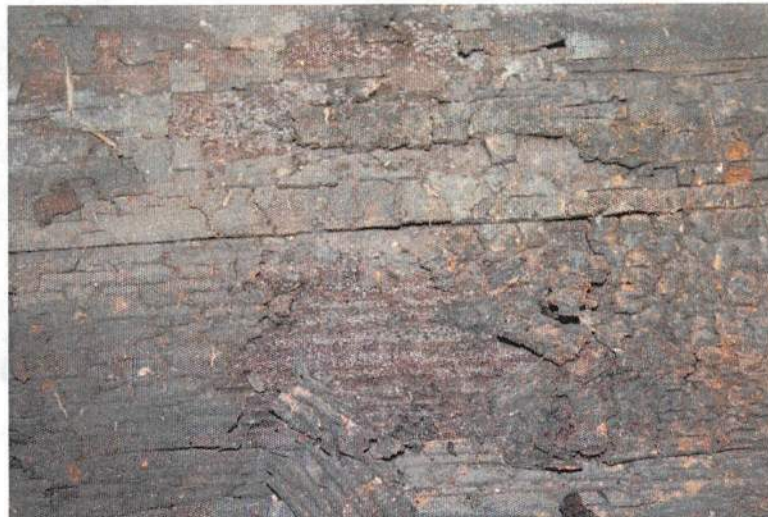
The forward bilge had several inches of standing water in it. According to park service staff, there was no bilge pump in this section of the ship and there had not been a bilge pump for several years. In this section of the ship, there were large formations of a white substance (assumedly a result of corrosion) on top of each of the large metal boats in the keelsons (Figure 4). There was also a section on the side wall of the ship that was exhibiting brown rot decay (Figure 5).

Figure 5: Brown rot decay on side wall of forward bilge.

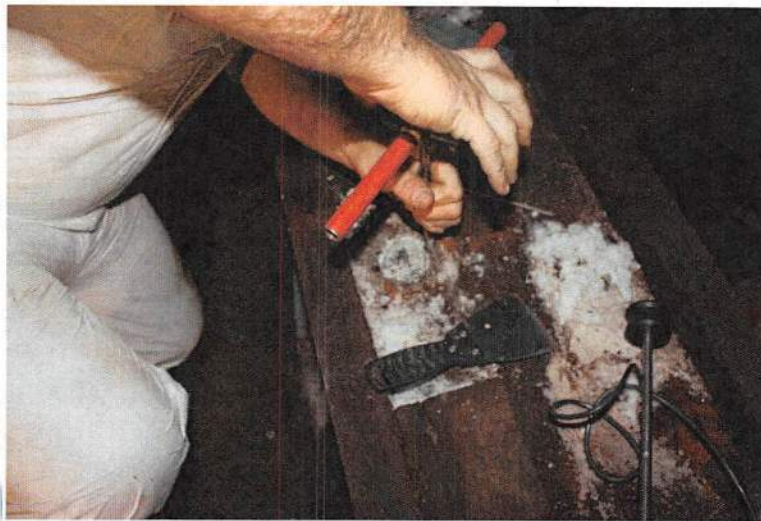
Figure 6: Increment core being taken on a keelson near two corroded bolts identifiable by the white corrosion product blossoms.

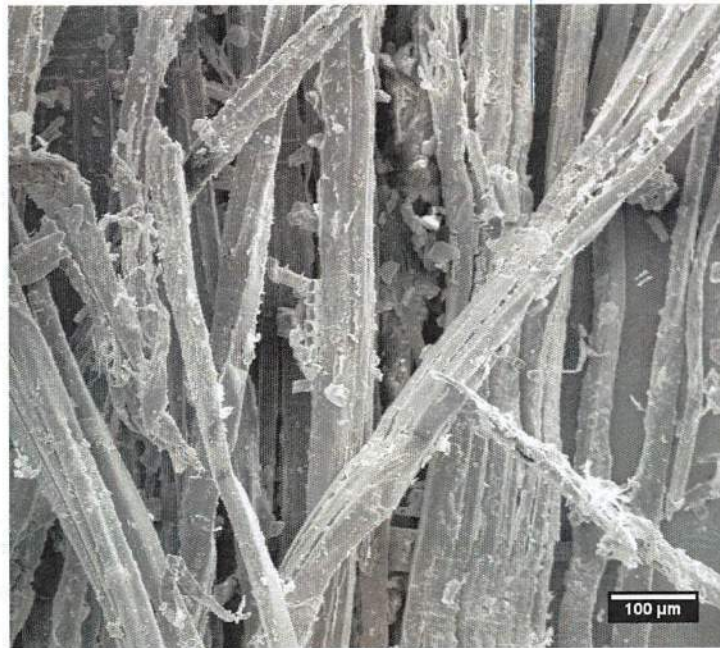
Figure 10: Scanning electron micrograph of salt damage wood taken from a joist in the forward bilge.

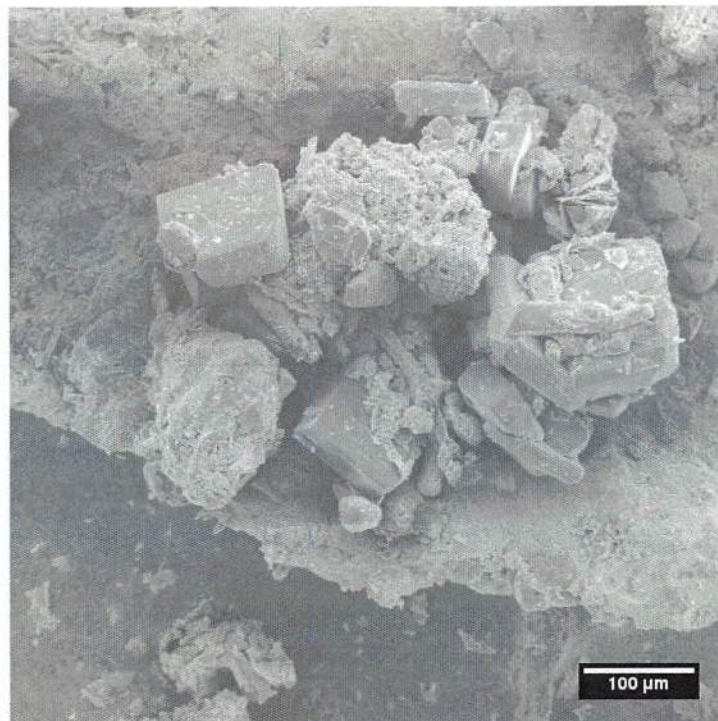
Figure 11: Scanning electron micrograph of a white deposit on top of a corroded fastener (Figure 4).
